DG2002-4.0-XXP-1Y-01A (H) Product upgrade notification

Date of notification: 24/02/2016

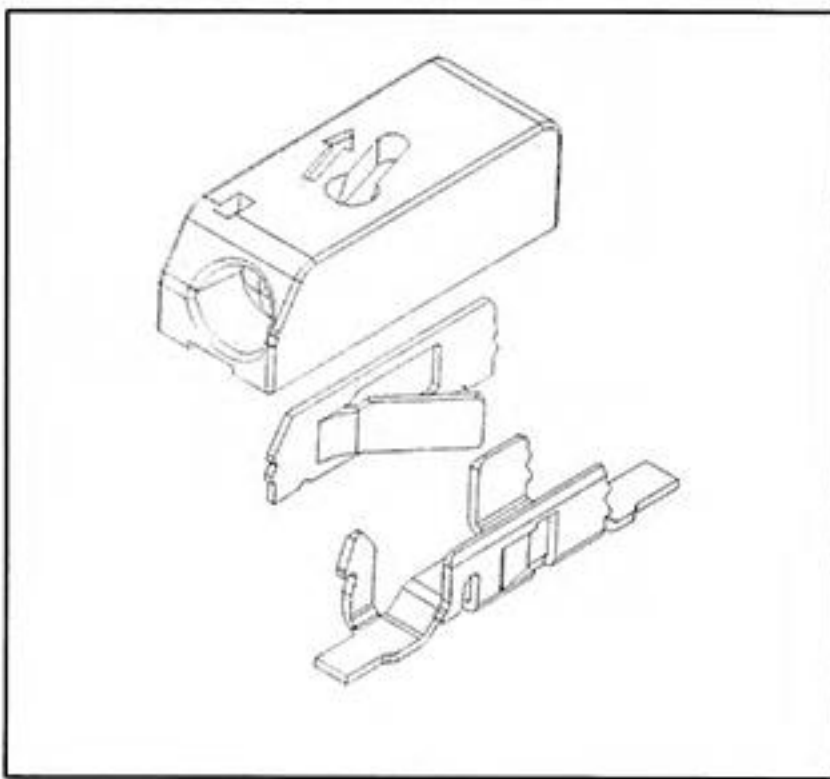
before upgrading

(a) after finishing wiring to the product of existing structure, we apply a force to wire, the force is vertical upward with the direction of wiring, but there is a separation risk between housing and pin when the force is up to 30N (the force of safety standard is 20N), in order to prevent wrong operation which results in abnormal product use, we design a new structure which can prevent the risk.

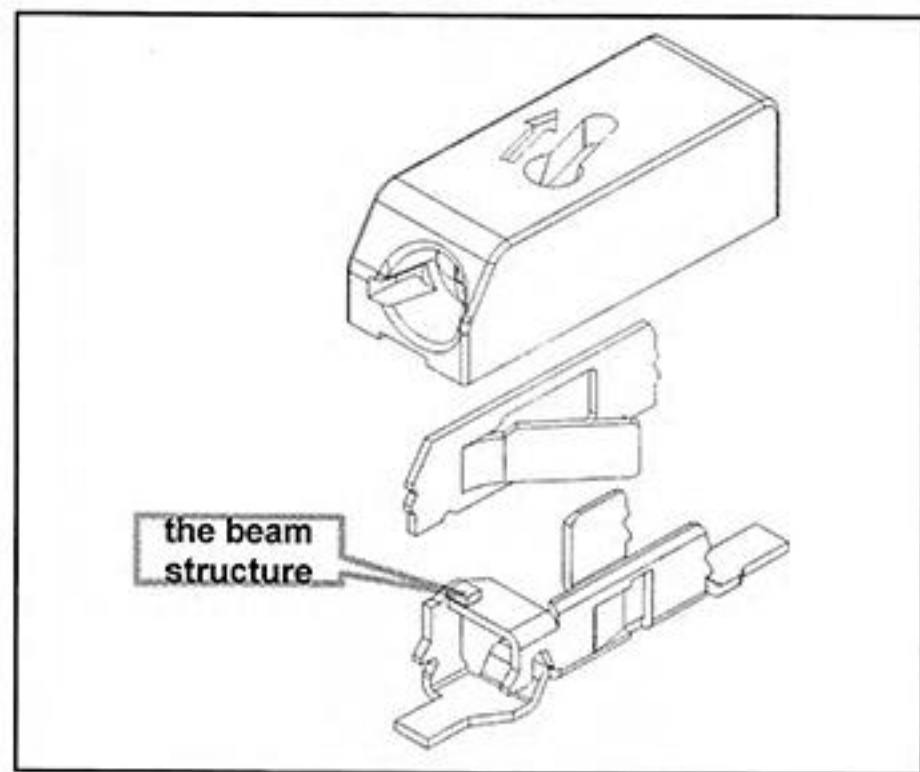
after upgrading

1. Upgrade issues: (1) Pin adds the beam structure to withstand the force of wire, the force is vertical upward with the direction of wiring, it can prevent housing and pin from separating.
(2) Upgraded product name is DG2002-4.0-XXP-1Y-100A(H)

(b) Take 02P product for example: new structure will ensure the reliability between housing and pin, when the force is over 60N, product is broken and the housing is still together with pin.
