Test Report No. XMNML1901705329 Date: 11 Dec 2019 Page 1 of 4

HOLLYLAND(CHINA) ELECTRONICS TECHNOLOGY CORPORATION LIMITED & HOLLYLAND(XIAMEN) TECHNOLOGY CORPORATION LIMITED

The following sample(s) was/were submitted and identified on behalf of the clients as: Material for: 25F/25T/4NT Series

Test Requested: Selected test(s) as requested by client.

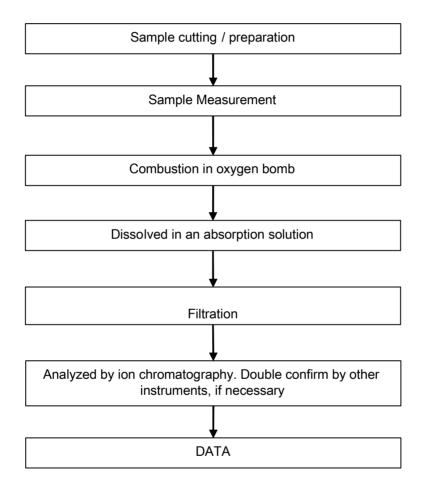
Halogen Testing Flow Chart

Test Method: With reference to EN 14582:2016, analysis was performed by IC.

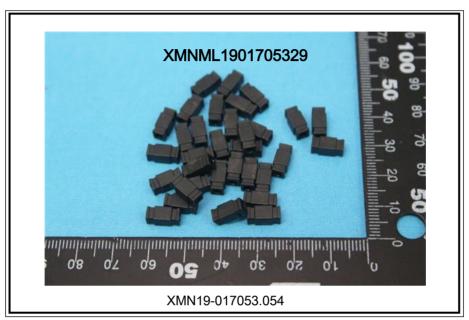
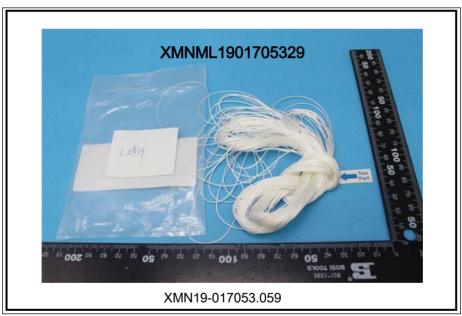
Sample photo:

Specimen No.	SGS Sample ID	Description
SN1	XMN19-017053.054	Black plastic tube(said to be"plastic tube")
SN2	XMN19-017053.059	White thread(said to be"Glass fiber")

Results and photos of No.059 in this report refer to No.006 in test report XMNML1901637201; Results and photos of No.054 in this report refer to test report XMNML1901705301
